DNA-TR-81-162

CHARGING AND DISCHARGING OF SPACECRAFT THERMAL CONTROL DIELECTRICS

Mission Research Corporation
5434 Ruffin Road
San Diego, California 92123

Technical Report

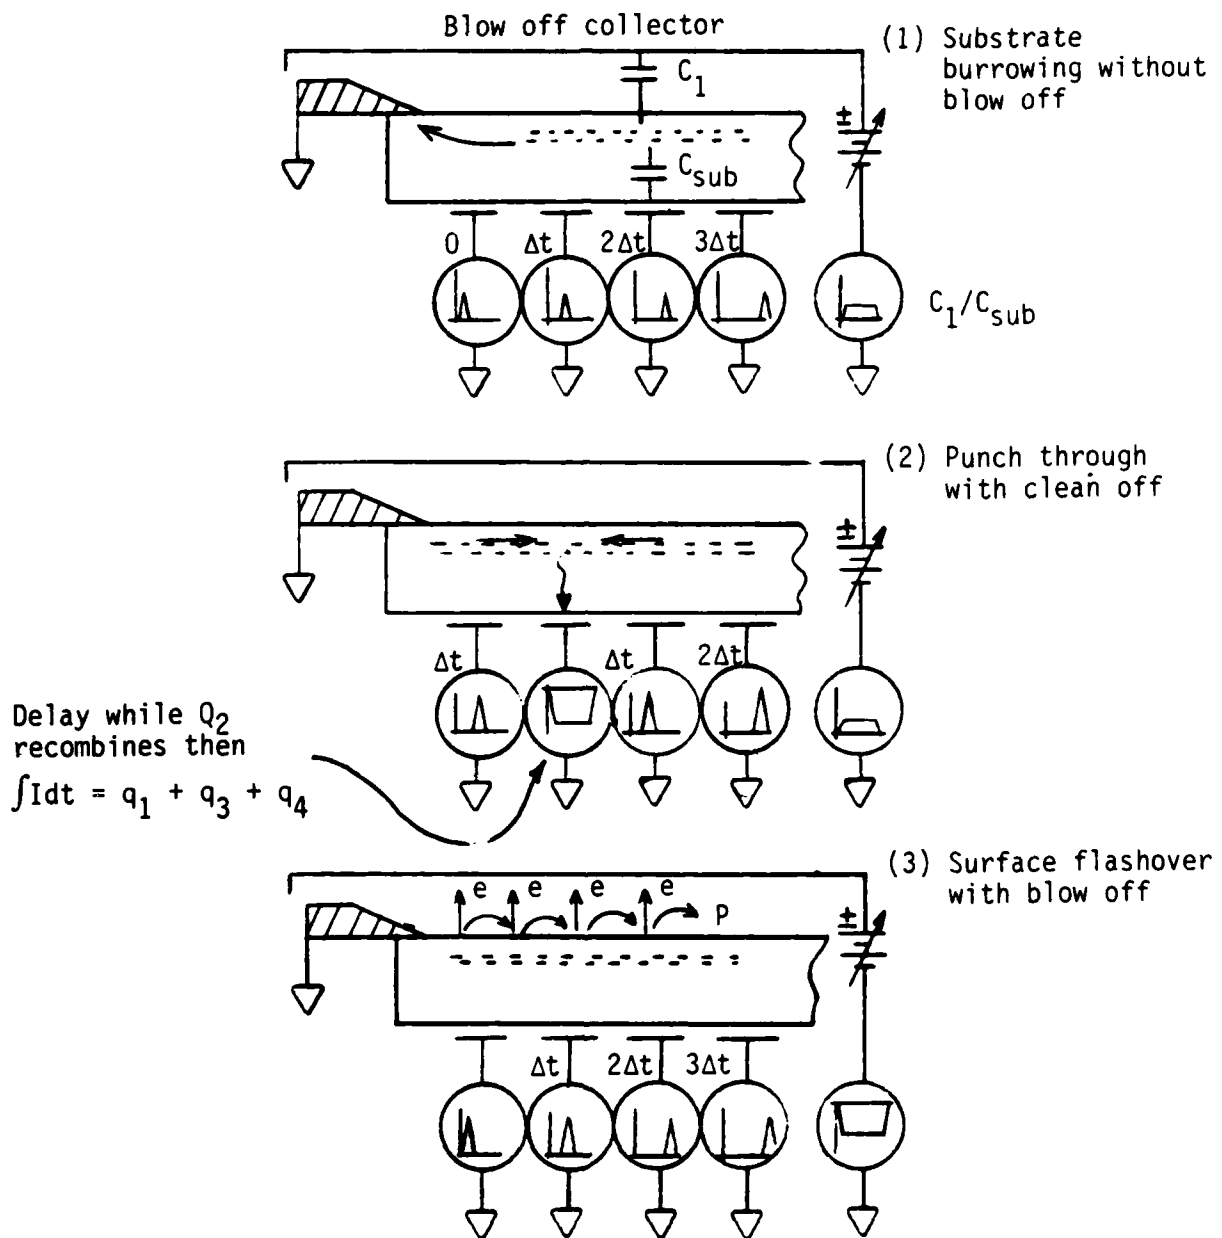
Figure 1. Schematic representation of three kinds of dielectric discharge and the transient electrical signals anticipated from each. The first represents subsurface burrowing of charge with no blow-off. The second is subsurface burrowing of charge with clean-off initiated by a punch through. The third is surface flash-over with blow-off.

Figure 1 schematically represents three kinds of dielectric discharge and the transient electrical signals anticipated from each.

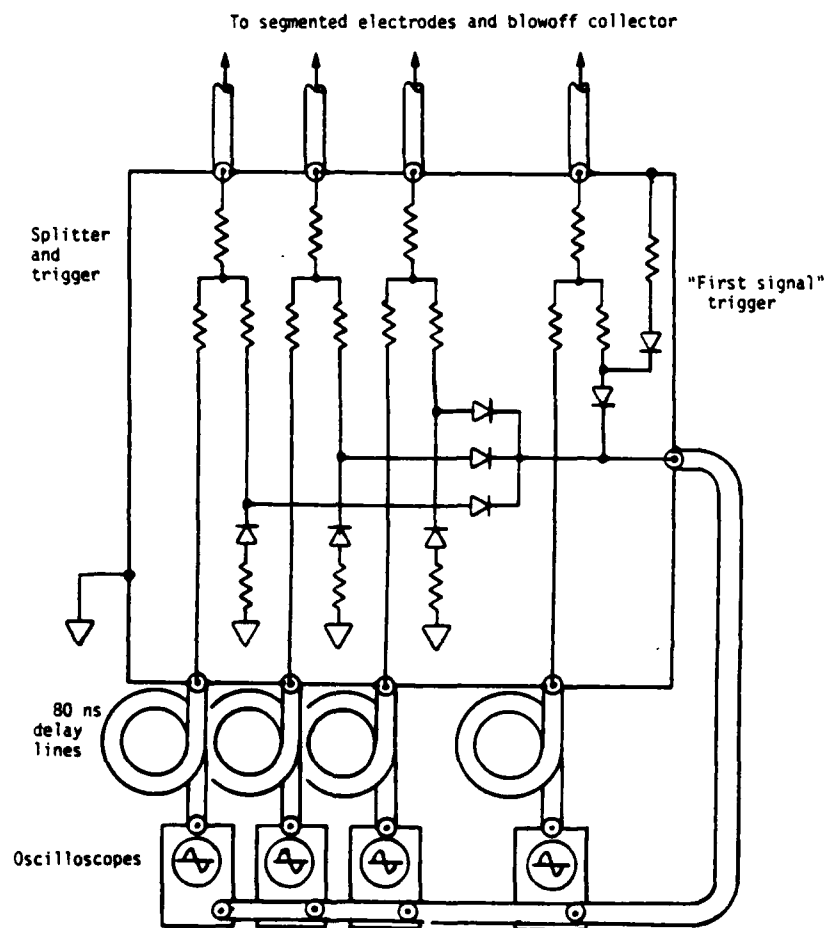
Figure 2b. Schematic representation of the transient data acquisition apparatus showing the signal splitters, "first signal" trigger, "or" gate delay lines and scopes. The delay lines and inherent delay in each scope resulted in apparent delays of $\sim 120 \pm 10$ ns for channels 1 - 4 and 200 ± 10 ns for channel 5. This figure is continued from Figure 2a.

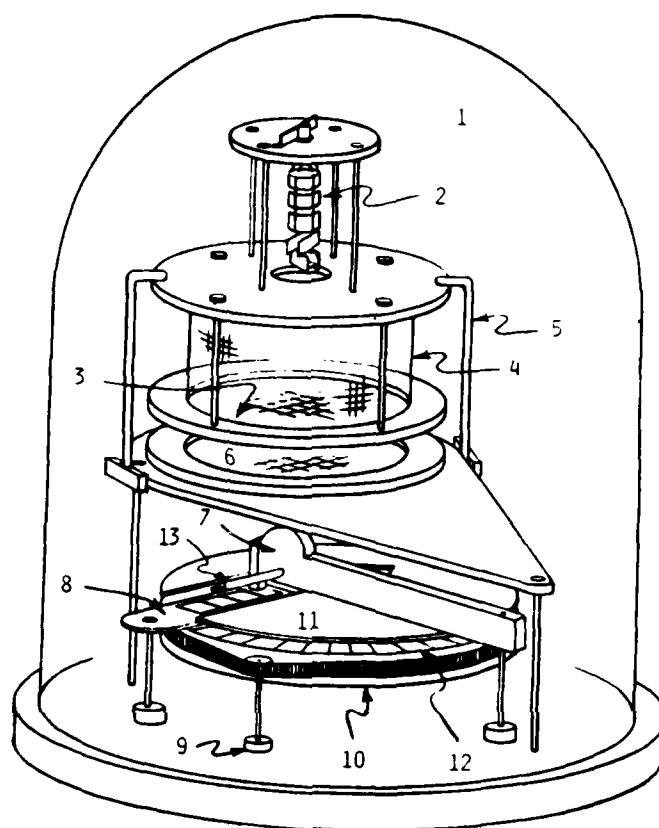
1. Bell jar
2. Electron gun
3. 0-30 kV acceleration grid
4. High voltage cage
5. Glass rod standoff's
6. Grounded acceleration grid
7. Electrostatic voltmeter on rotary feed through
8. Shutter on rotary feed through
9. Turn table drive feed through
10. Turn table
11. Aperture plate and blow-off collector
12. Sample edge clamps (razor blades)
13. Sweeping Faraday Cup

Figure 3. Pictorial representation of the experimental apparatus inside the vacuum bell jar.

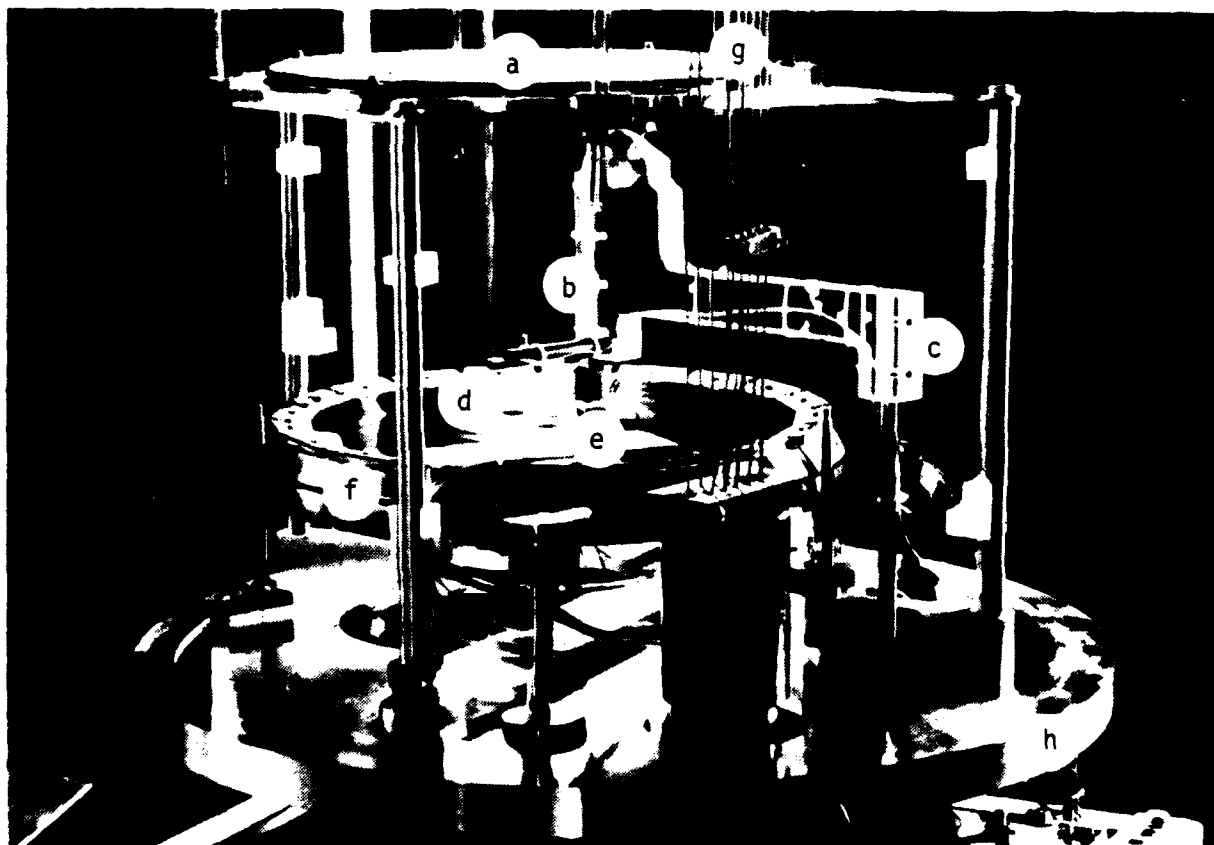
Figure 4. Photograph of the apparatus (partially assembled) showing (from the top): the grounded acceleration grid (a), the TREK probe (b), on the rotating arm (c), suspended over the sample and segmented back plate (d), the shutter (e), the turn table (f), high voltage electron gun wires (g) and bell jar base plate (h).

which was a stainless steel screen of 0.0025 cm (0.001") woven wire with greater than 90% transparency. Also apparent in this figure is the rotating swing-arm, supporting the TREK probe and the sweeping Faraday cup; the rotating shutter; and the turntable rotator. The circumferential electrodes are just visible through the transparent sample which is held in place with 20 clamps made of single-edge razor blades around the periphery.

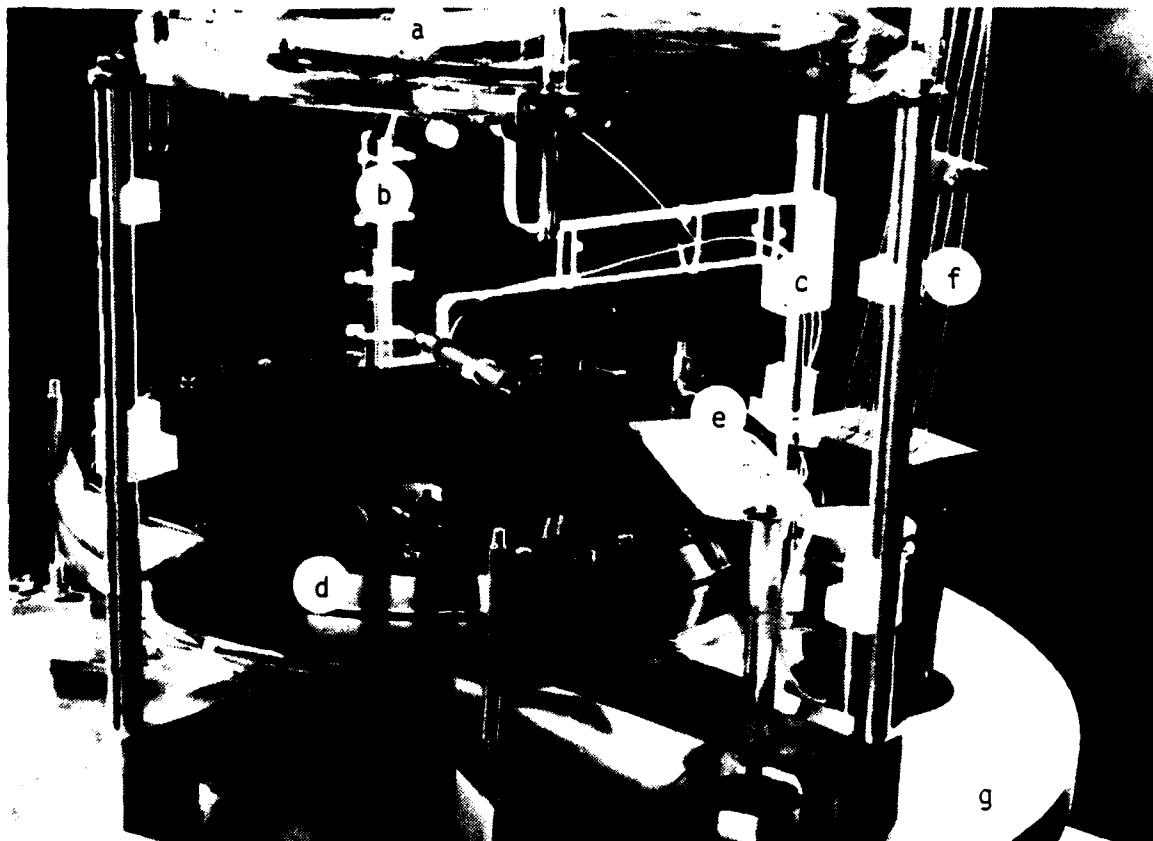
Figure 5. Photograph of the apparatus from another aspect showing the second acceleration grid (a), above the TREK probe (b), on the swing arm (c), over the sample on the turntable (d), the shutter (e), gun wires (f), and base plate (g). Notice the razor blade clamps.

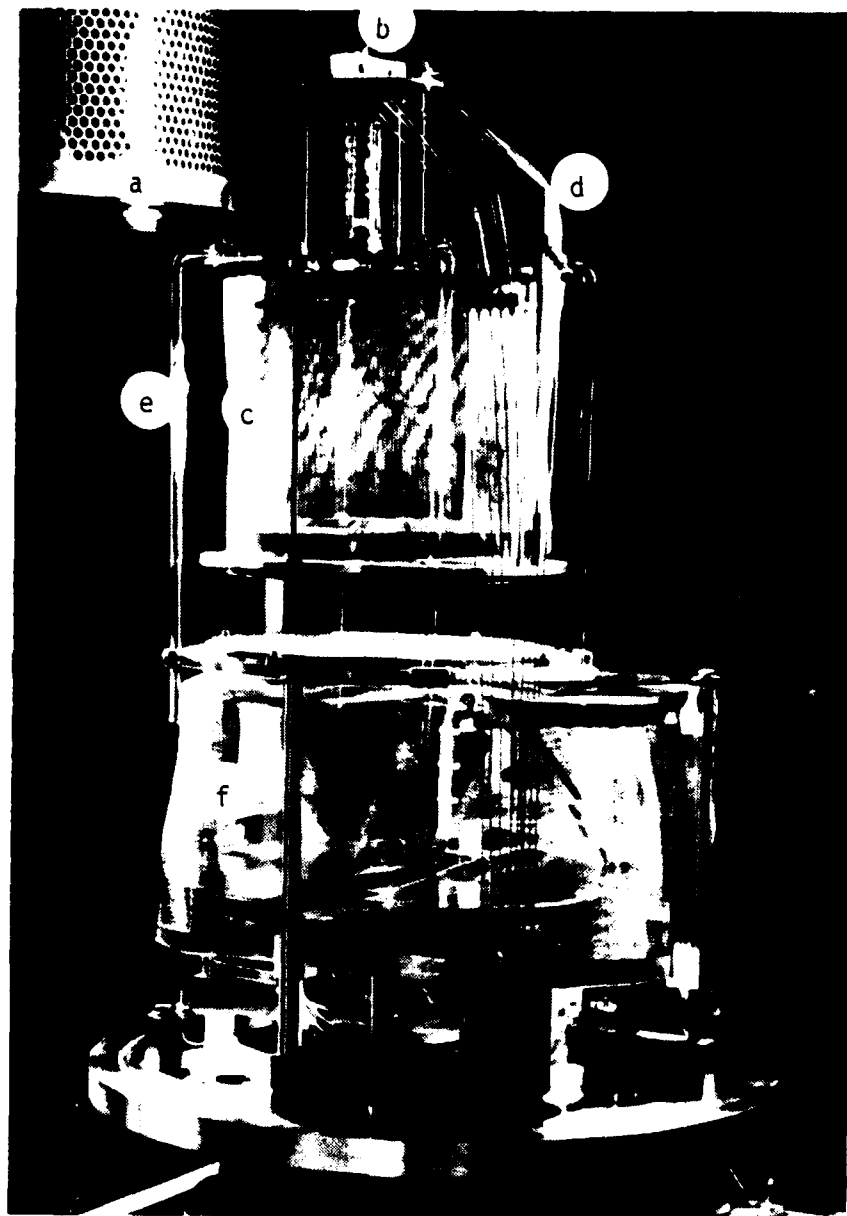
Figure 7. Photograph of the apparatus showing the bell jar (a), electron gun (b), high voltage Faraday cage (c), high voltage gun leads (d), supported on glass rods (e), above the low voltage Faraday cage and blow-off collector (f), surrounding the turntable supporting the sample.

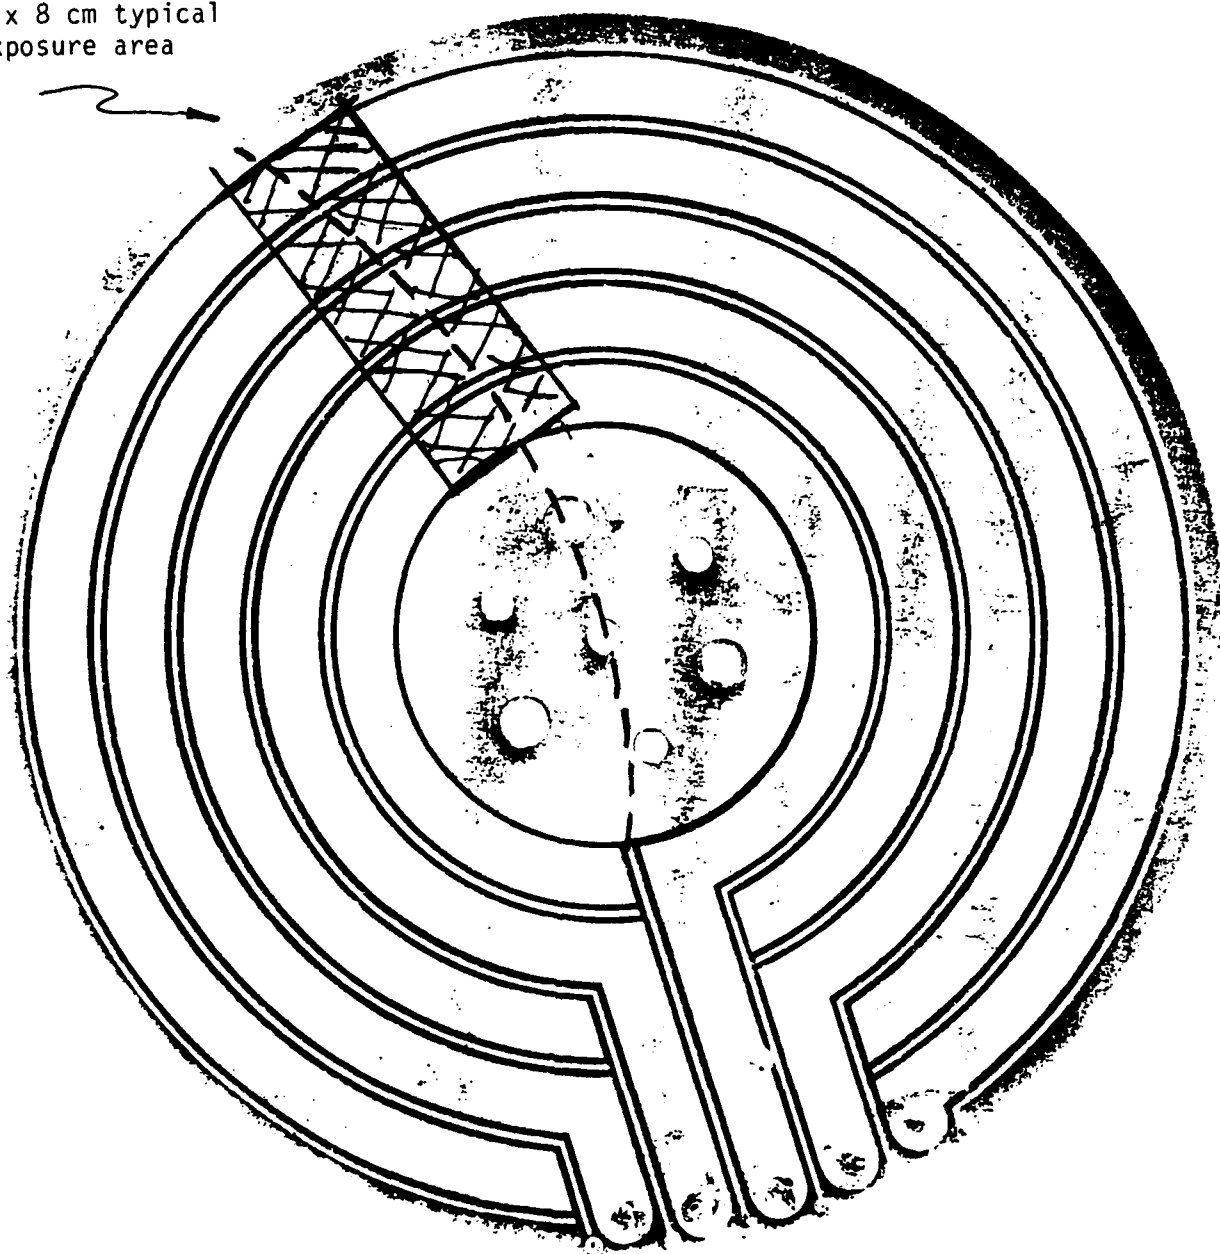
Figure 8. Reproduction of the 25 cm diameter printed circuit board with its circumferential electrodes. A typical exposure area $\approx 4 \times 8$ cm is shown shaded and the 20 cm radius arc electrostatic voltmeter sweeps is shown as a dotted line.

Figure 8 is a photograph of the segmented printed circuit board with a typical irradiation area and the TREK sweep included.

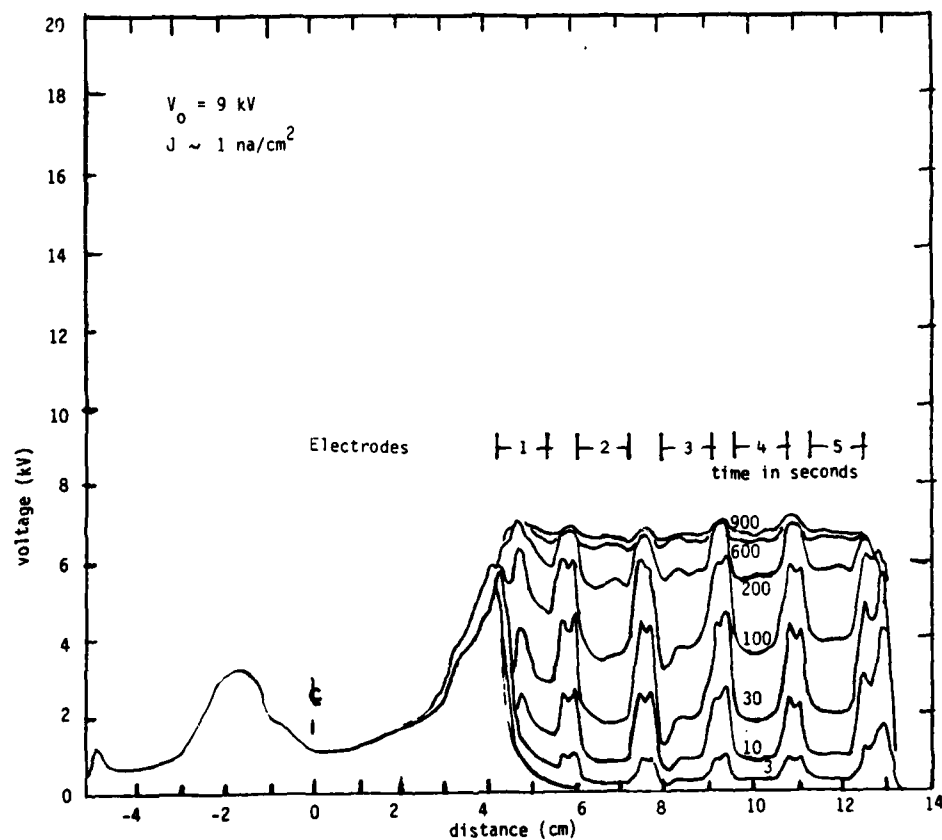
Figure 9. Typical potential profiles from a charging sequence for 0.005 cm Kapton exposed to $\approx 1 \text{ nA/cm}^2$ of 9 keV electrons. Exposure times (in seconds) are indicated.

This sample attained an asymptotic voltage of ≈ 7.2 kV which is 1.8 kV less than the charging potential. Note: The highest profile is probably slightly less than the asymptotic form, because the time involved would have been excessively long at this current density. At higher

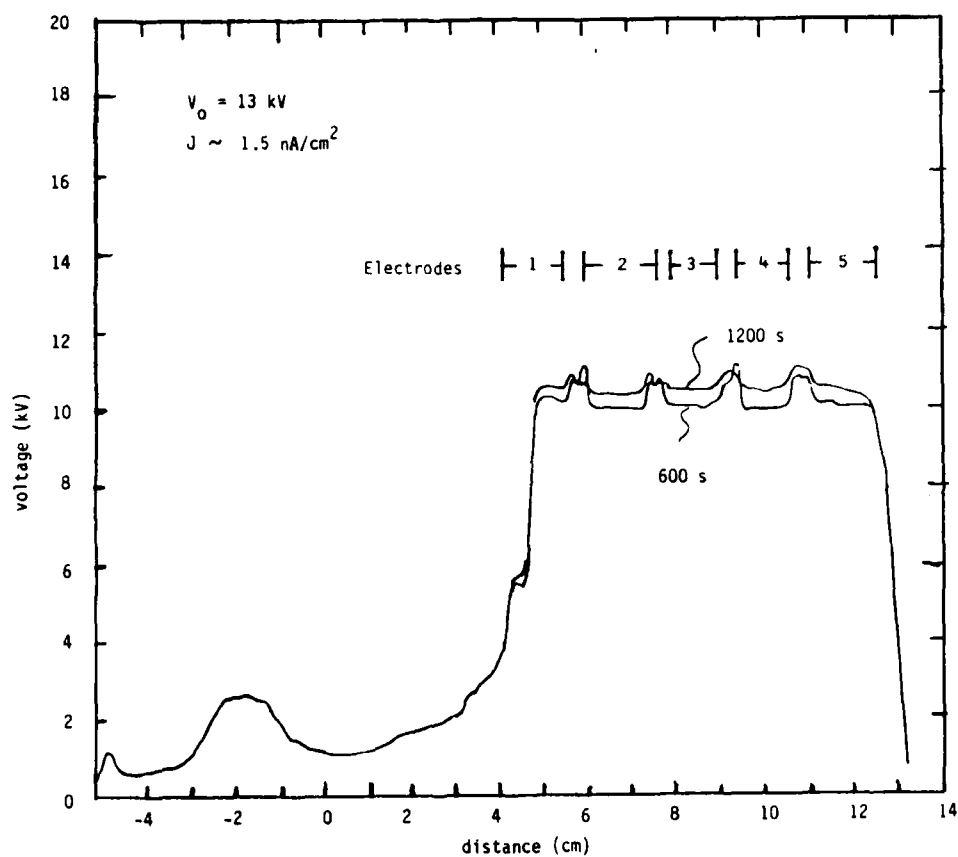
Figure 10. Asymptotic charging of 0.005 cm Kapton with 1.5 nA/cm^2 of 13 kV electrons.

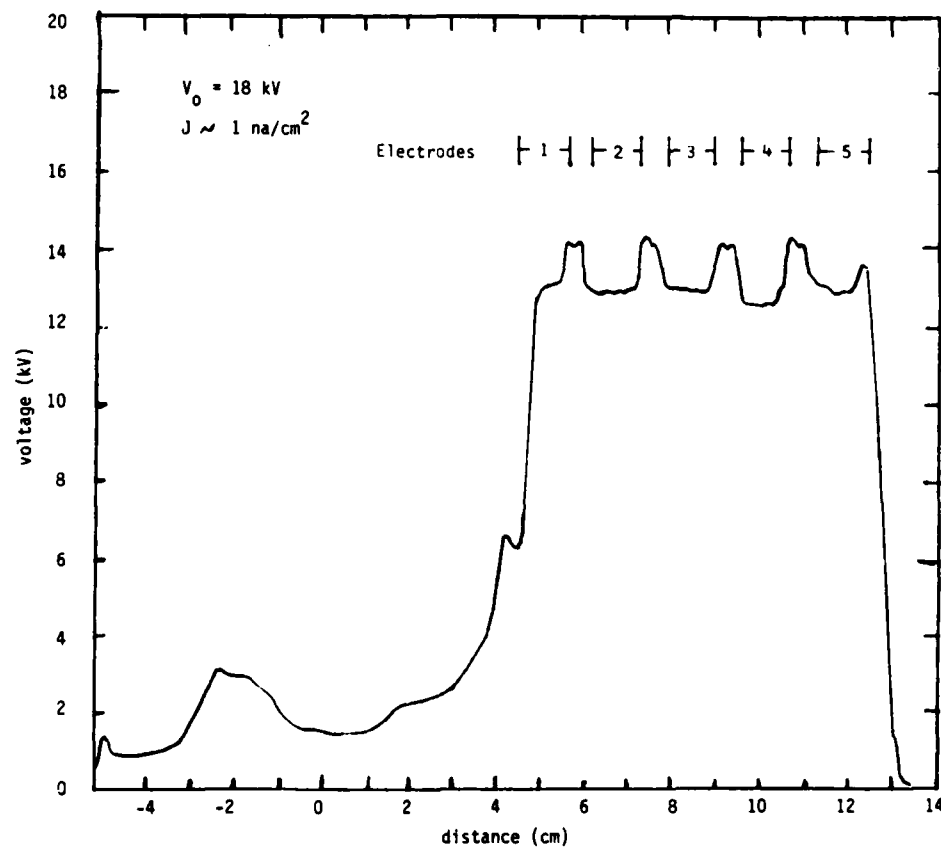
Figure 11. Asymptotic potential profile for 0.005 cm Kapton, charging with 1 nA/cm² of 18 kV electrons.

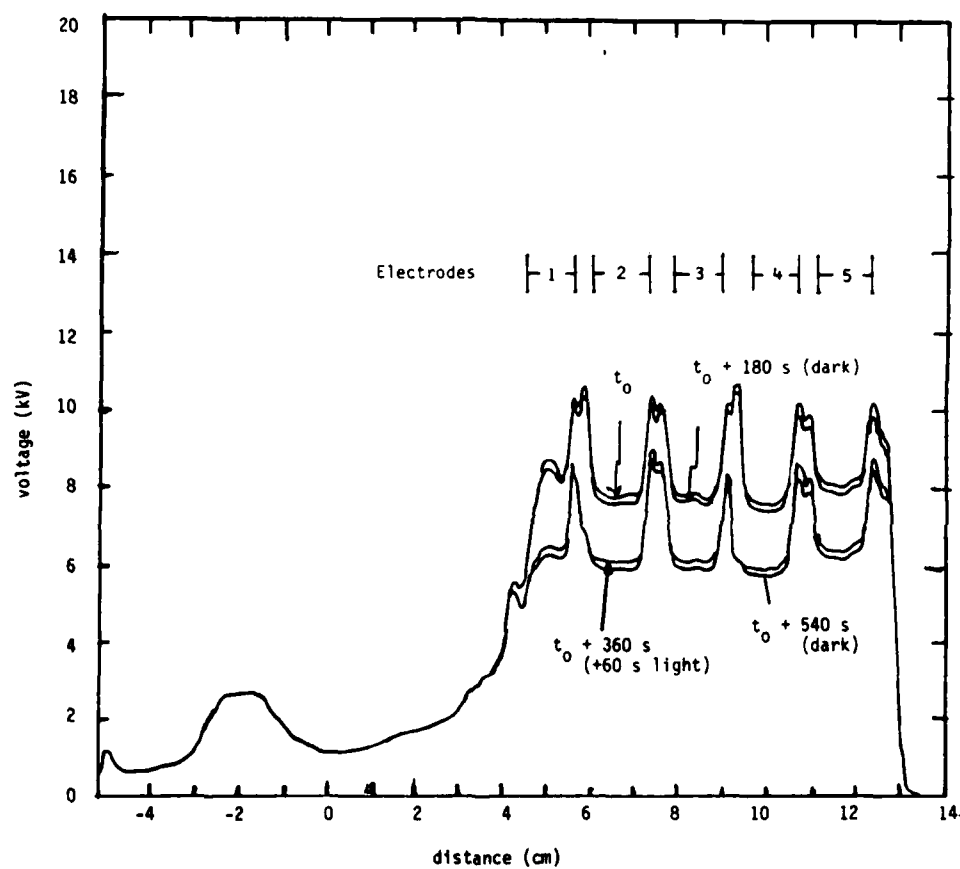
Figure 12. Decay of potential with time after charging with 1 nA/cm^2 of 13 keV electrons. Shows increase in conductivity due to having room lights on.

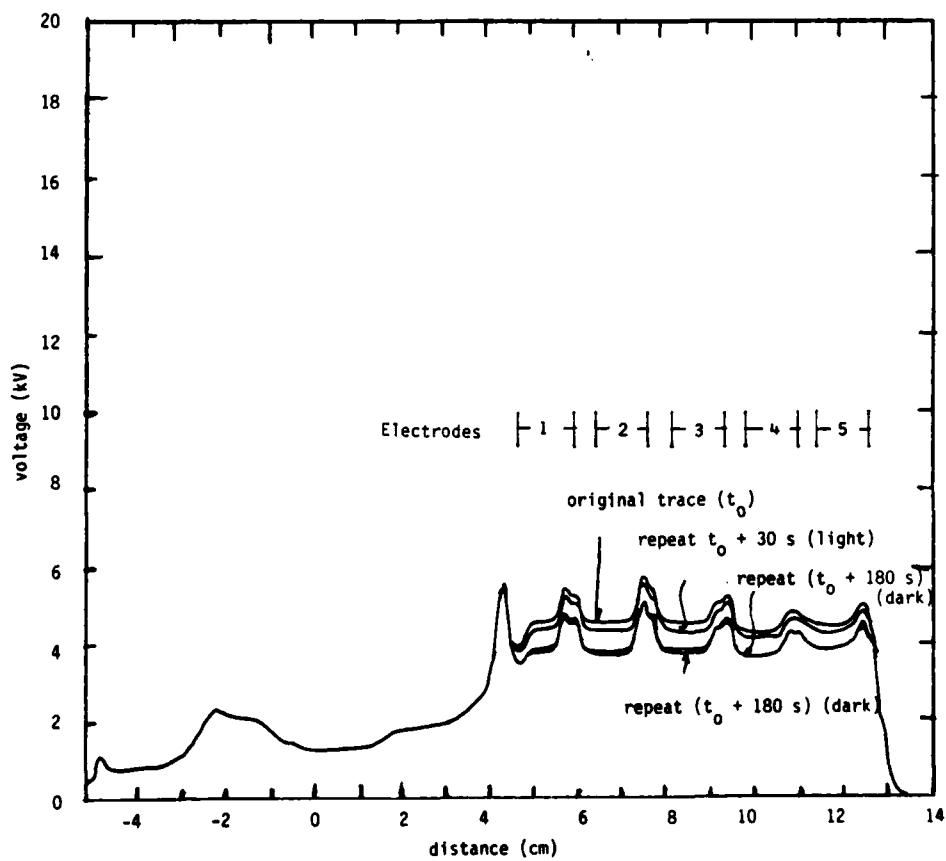
Figure 13. Another time decay of voltage showing the enhancement of conductivity due to room lights.

Figure 13 is another example showing the decay of voltage with lights on and with lights off. The sample had been left with no irradiation for ≈ 2 hours after charging with $\approx 3 \text{ nA/cm}^2$ at 19 kV. The time elapsed between each trace is the same. In addition, between the two upper traces, room lights were on for 30 seconds; between the two middle traces, twice as much light was on for 60 seconds; between the last two, no light was on.

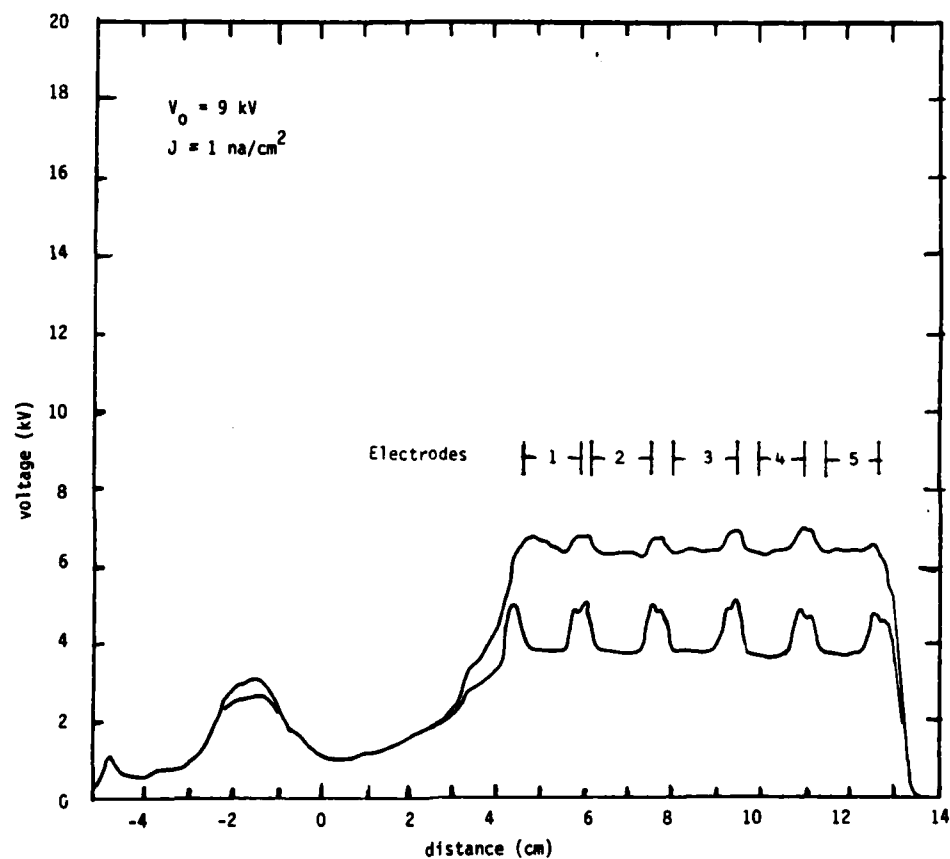
Figure 14. Decay of potential over two hours after charging with 1 nA/cm^2 at 9 keV.

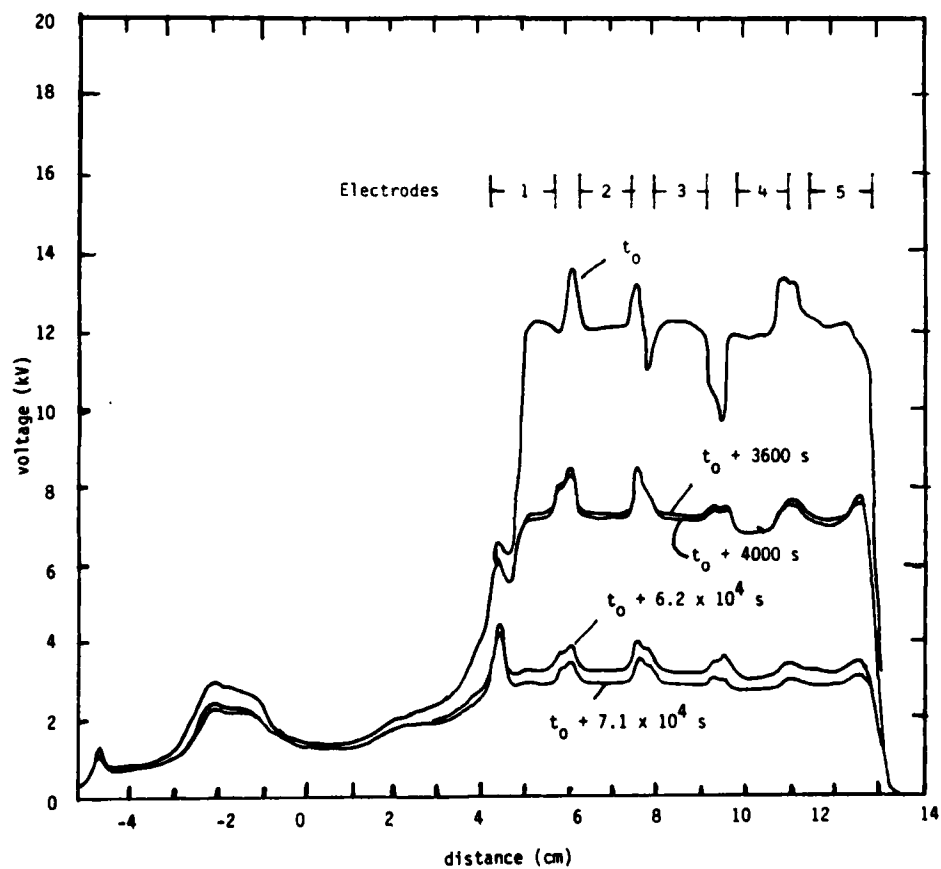
Figure 15. Decay of potential over 1 hour and 20 hours, after charging at 5.3 nA/cm^2 and 18 kV. No lights on.

Figure 15 shows two potential profiles taken approximately 1 and 20 hours after charging. From these data one would infer a conductivity of $\approx 4.4 \times 10^{-17} \text{ (ohm cm)}^{-1}$ during the first 60 minutes. The conductivity is $3.6 \times 10^{-18} \text{ (ohm cm)}^{-1}$ during the next 17 hours and a conductivity of $4.8 \times 10^{-18} \text{ (ohm cm)}^{-1}$ during the period from 17 to 20 hours after charging.

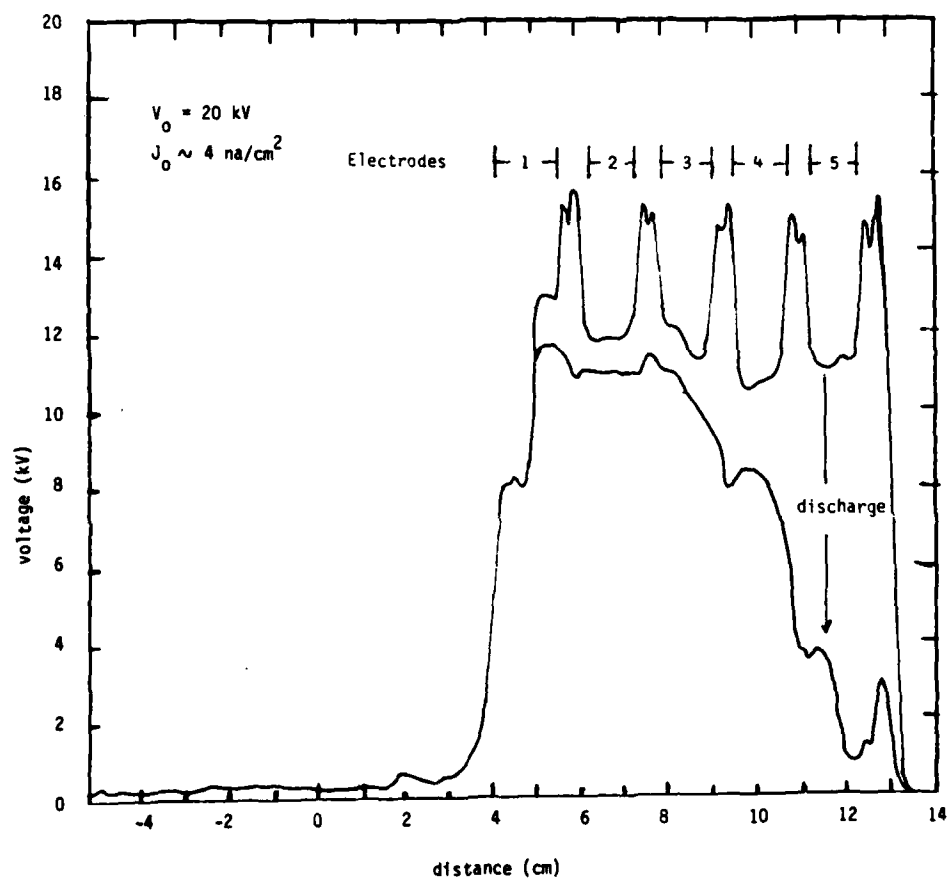
Figure 16. Potential profiles before and after a discharge induced by the TREK probe striking the metal at the edge of the sample.

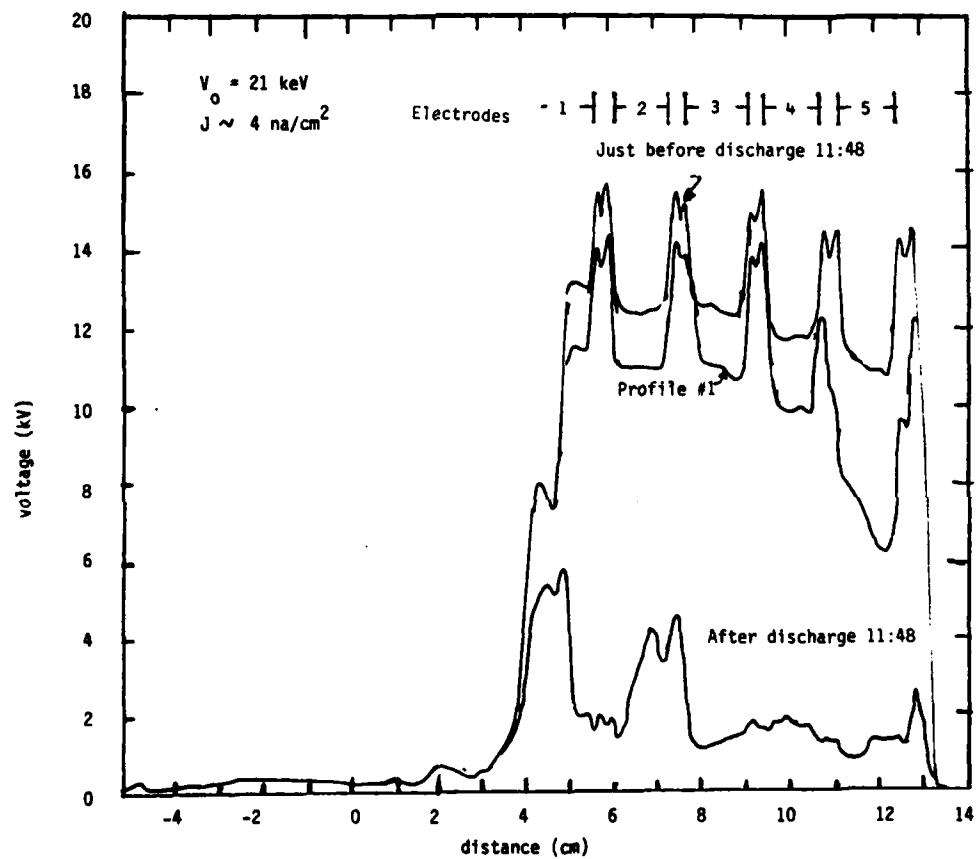
Figure 17. Potential profiles showing two minutes of charging at 21 kV with 7 nA/cm², and profile after discharge induced by TREK striking metal at the edge of the sample.

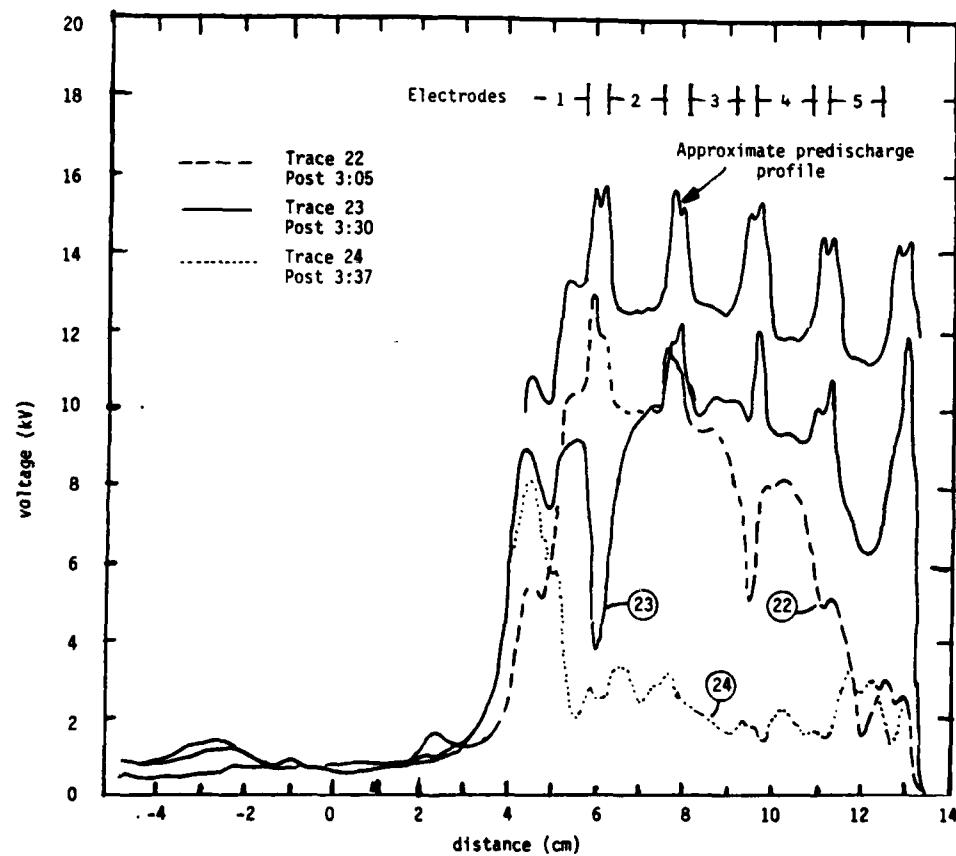
Figure 19. Potential profiles for 0.005 cm Kapton exposed to 4 nA/cm^2 of 26 kV electrons before and after discharges 3:05, 3:30, and 3:37.

Figure 19 shows three potential profiles for 0.002" Kapton after three different discharges. Before Trace 22, the sample had been charging for more than 8 minutes with 4 nA/cm² at 26 kV, when it discharged. Charge can be seen to be missing from over electrodes 4 and 5. A 5 s irradiation at ≈ 75 nA/cm² and 26 kV filled in most of that missing charge and caused a discharge over electrode 1 which we can see in Trace 23. Both these sweeps show preferential discharges over the low capacitance regions between the back surface electrodes. For instance, Trace 22 has a peak at ≈ 6 cm and a valley at ≈ 9 cm, while Trace 23 has a valley at ≈ 6 cm and a peak at ≈ 9 cm. 5 seconds more at 70 nA/cm² caused a discharge which cleared the charge off almost all the sample except over Ch 1. The discharge which occurred just before Trace 24 is shown in Figure 20.

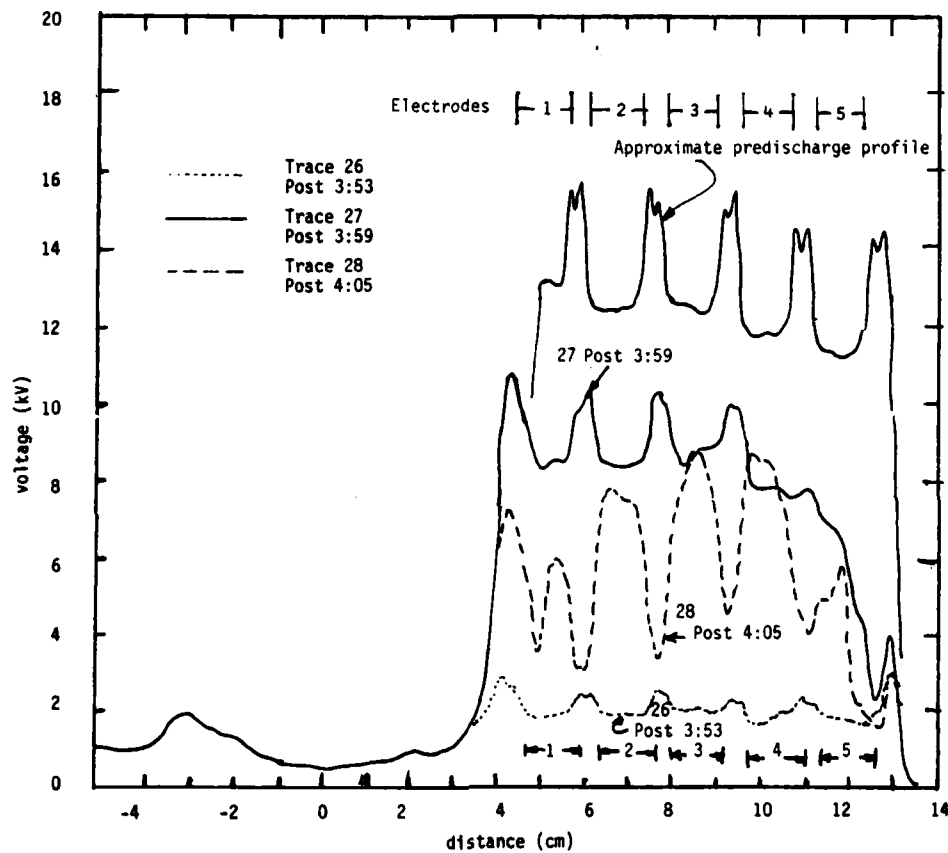
Figure 21. Potential profiles for 0.005 cm Kapton exposed to 75 nA/cm² of 26 kV electrons before and after events 3:53, 3:59, and 4:05.

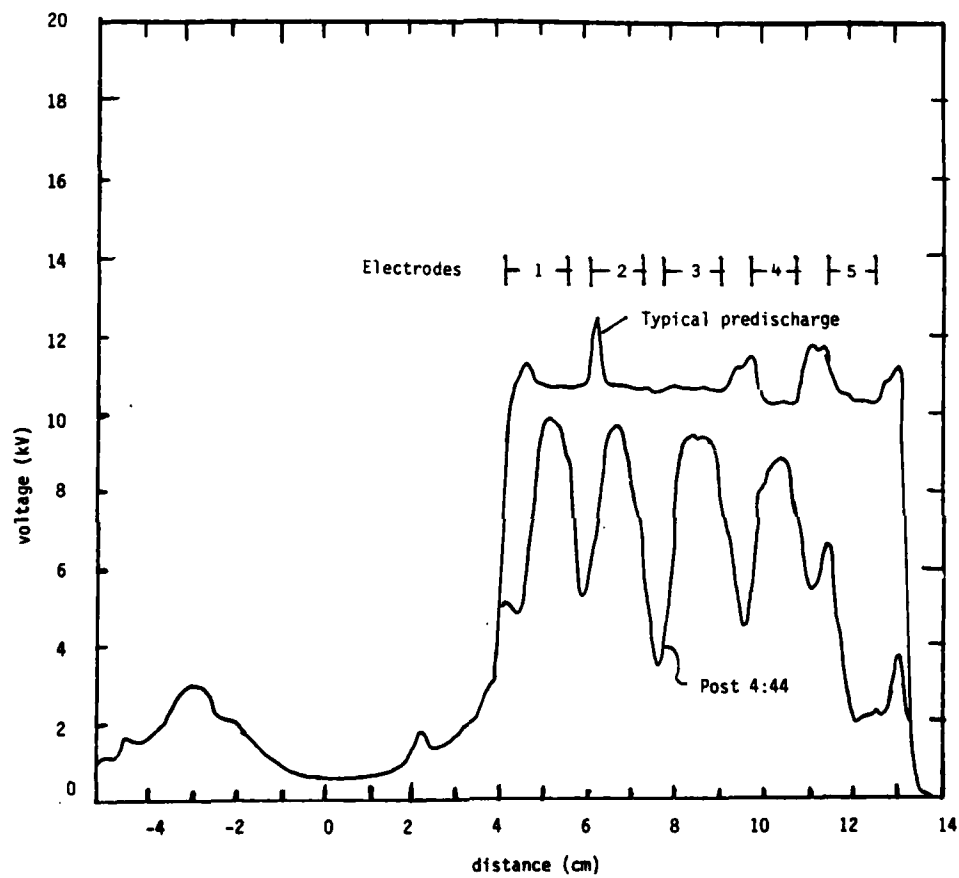
Figure 23. Actual post-discharge profile and probable pre-discharge profile. Charging with 75 nA/cm^2 of 26 kV electrons.

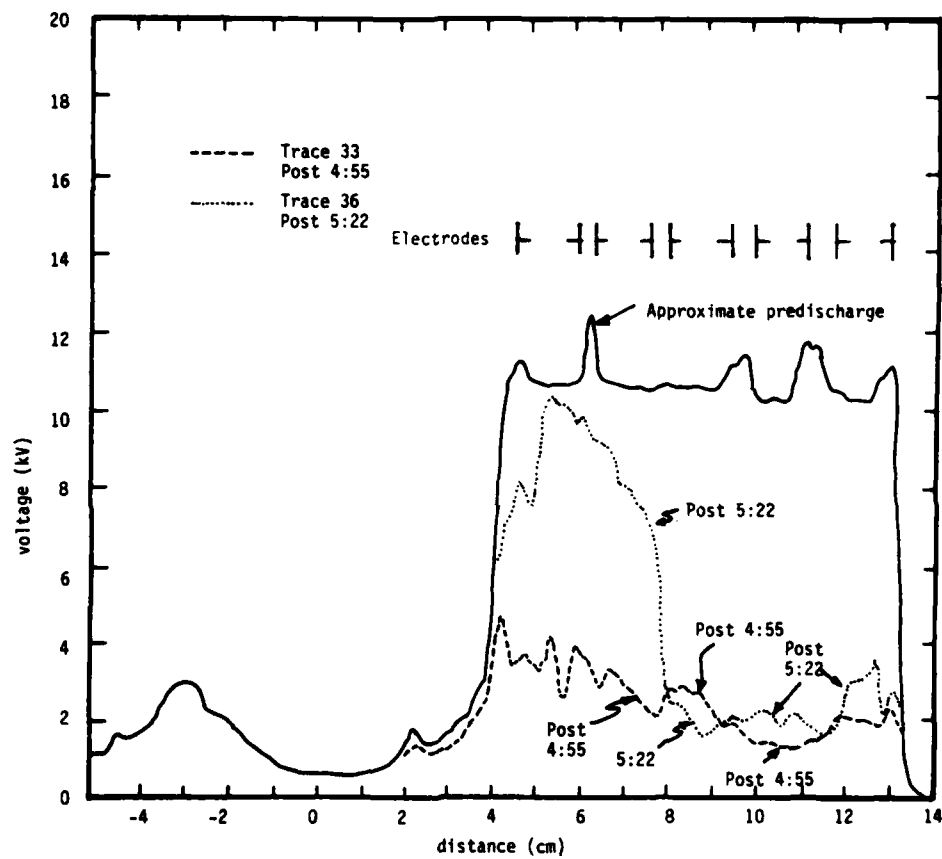
Figure 25. Two post-discharge profiles and estimated pre-discharge profile. Charging with 75 nA/cm^2 of 26 kV electrons.

Figure 25 shows a set of post discharge potential profiles for events 4:55 and 5:22. Notice that whereas event 4:55 uniformly discharged the sample surface, event 5:22 involves principally the areas over electrodes 3, 4, and 5. These observations are supported by the transient data in Figures 26 and 27. In event 4:55, signals are clearly seen in all five electrodes while in event 5:22, the signals on electrodes 3, 4, and 5 are significantly greater than on electrodes 1 and 2. The blow-off collector intercepted about 8 μ C

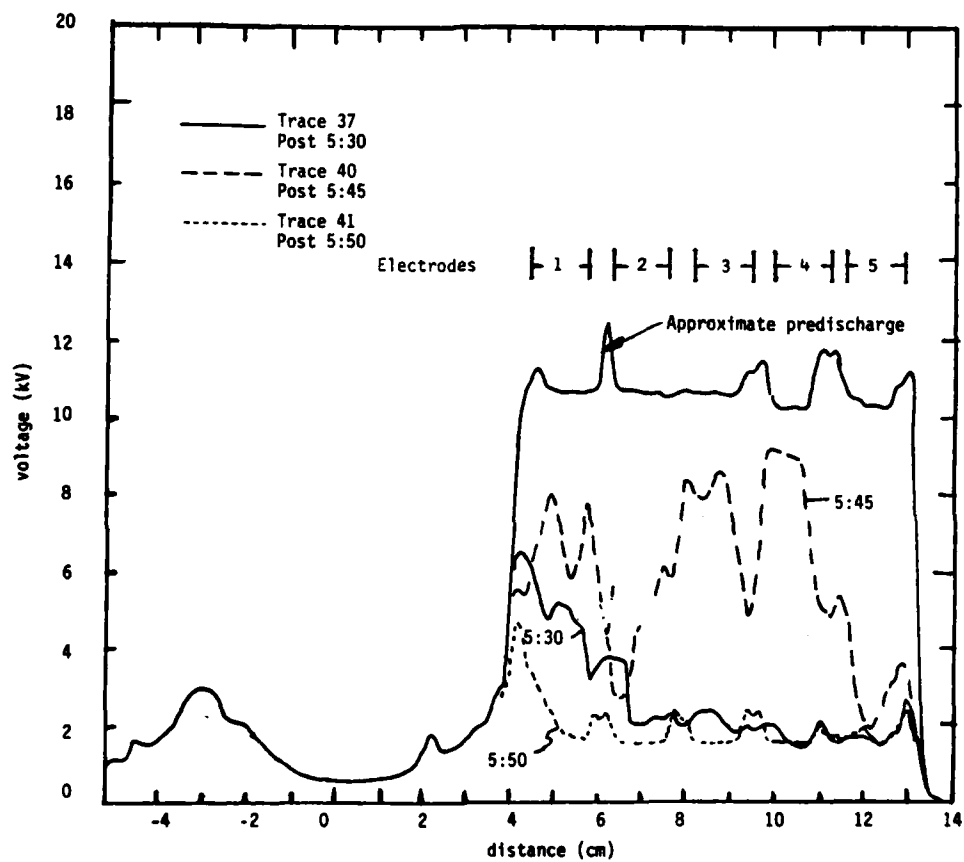
Figure 28. Three post-discharge potential profiles and estimated pre-discharge profile. Charging with 40 nA/cm² of 26 kV electrons.

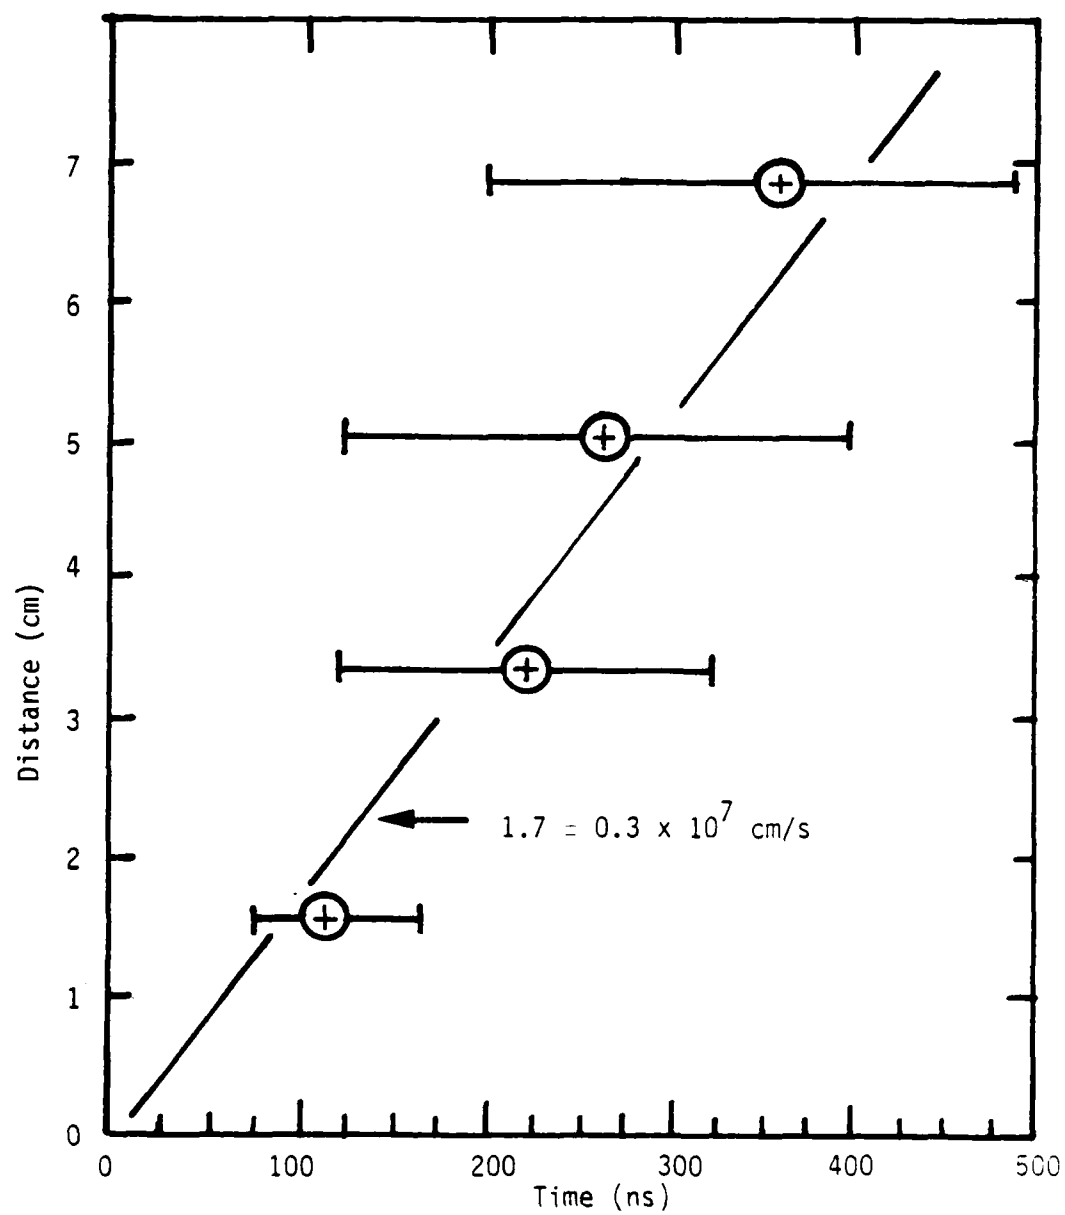
Figure 32. Discharge distance versus time after initiation for 23 transient discharge events on 0.005 cm Kapton.

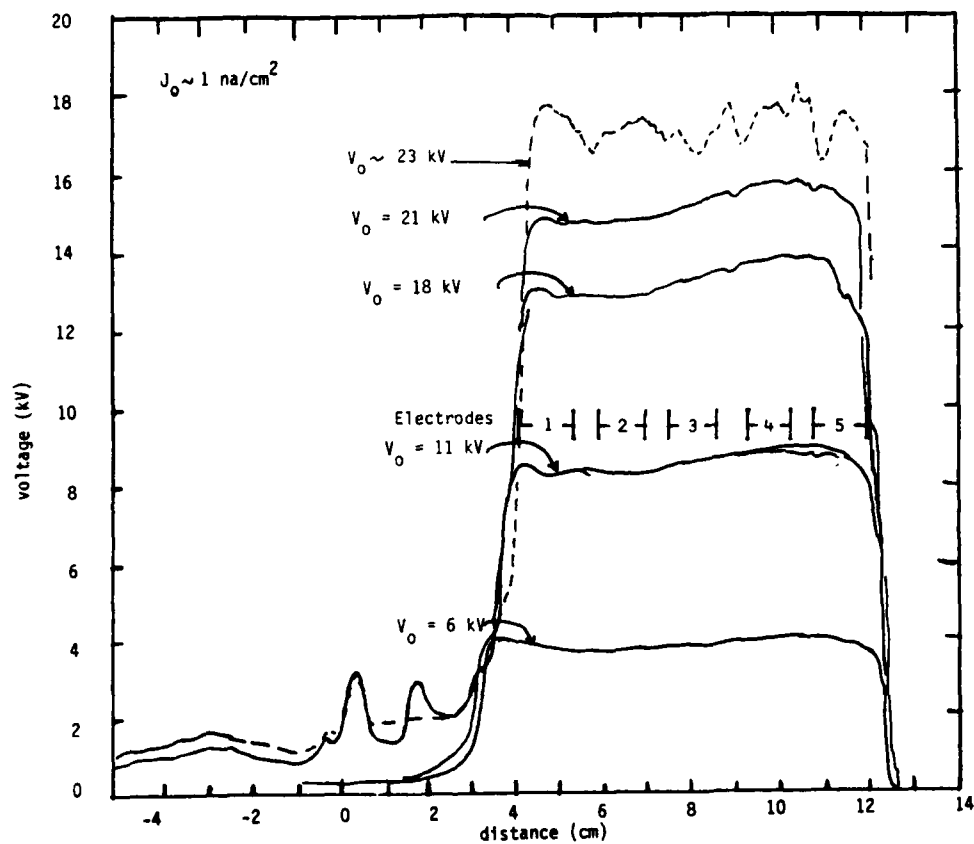
Figure 33. Potential profile measurements for 0.013 cm Teflon exposed to monoenergetic electrons of 6 kV, 11 kV, 18 kV, 21 kV, and 23 kV.
